# Manhole Inspection Summary

## Manhole # S31EE2008MH

Insp Date: **12/6/06 10:11 AM**

**Location** Address: **5609 ENDERLY RD**

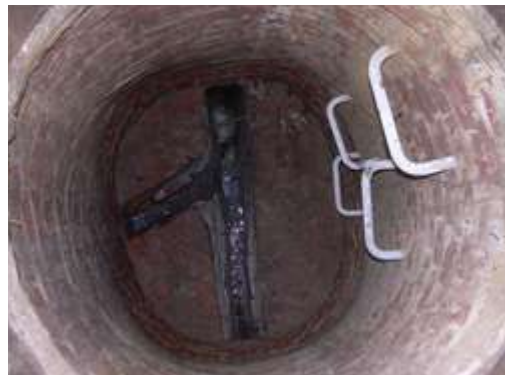
Top View

Bench and Channel debris.

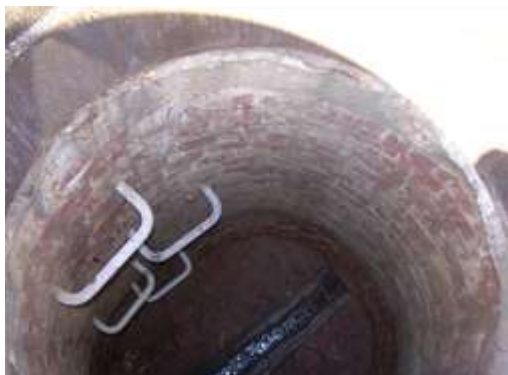
Defect

Frame leaks. Adjustment deterioration and infiltration. Corbel and Barrel infiltration

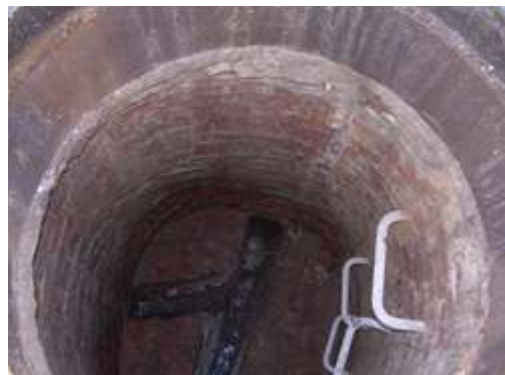
Defect

Frame leaks. Adjustment deterioration and infiltration. Corbel and Barrel infiltration - other side.

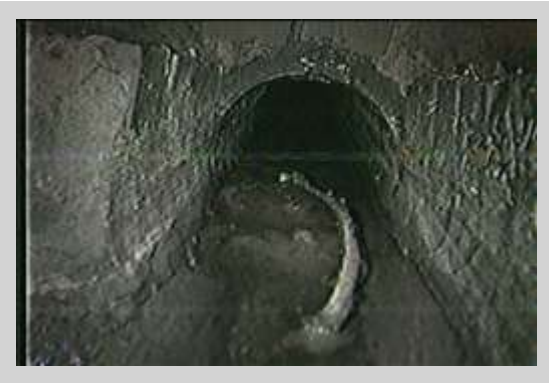
### 8 in. Circular Gravity Sewer Pipe Out @ 12 O'Clock

Channel cracks.

Deposits: ☐ None ☒ **Mud** ☐ Sludge ☒ **Debris** ☒ **Grease**

Infiltration: **Evidence** Pipe Seal Cond: **Unknown**

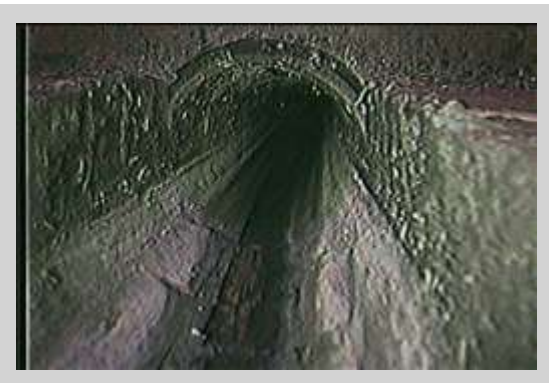
### 8 in. Circular Gravity Sewer Pipe In @ 6 O'Clock

Deposits: ☐ None ☐ Mud ☐ Sludge ☐ Debris ☒ **Grease**

Infiltration: **Evidence** Pipe Seal Cond: **Unknown**

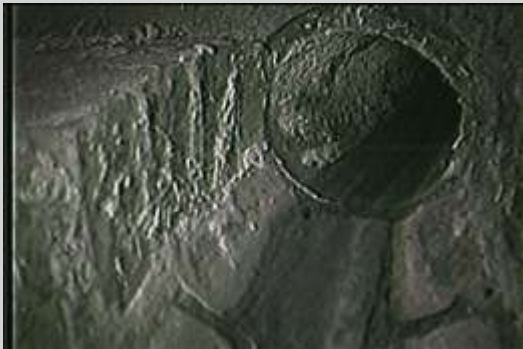
6 in. Circular Gravity Sewer  
Pipe In @ 8 O'Clock

Deposits: ☐ None ☐ Mud ☐ Sludge ☐ Debris ☒ **Grease**

Infiltration: **Evidence** Pipe Seal Cond: **Unknown**
